# Uniform Mitigation Verification Inspection Form

| Address: 1234 Louie Test Street | | Home Phone: 407-466-8921 |
| Year of Home: 2016 | # of Stories: 1 | Email: info@acfindpection.com |

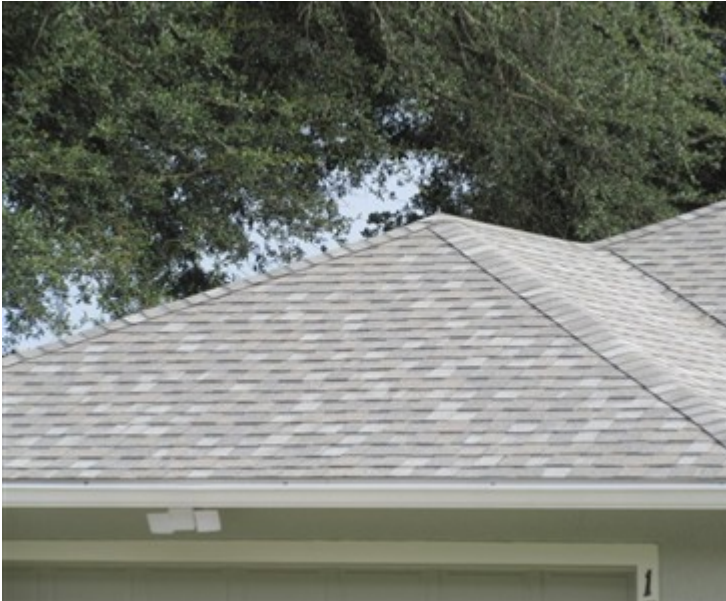
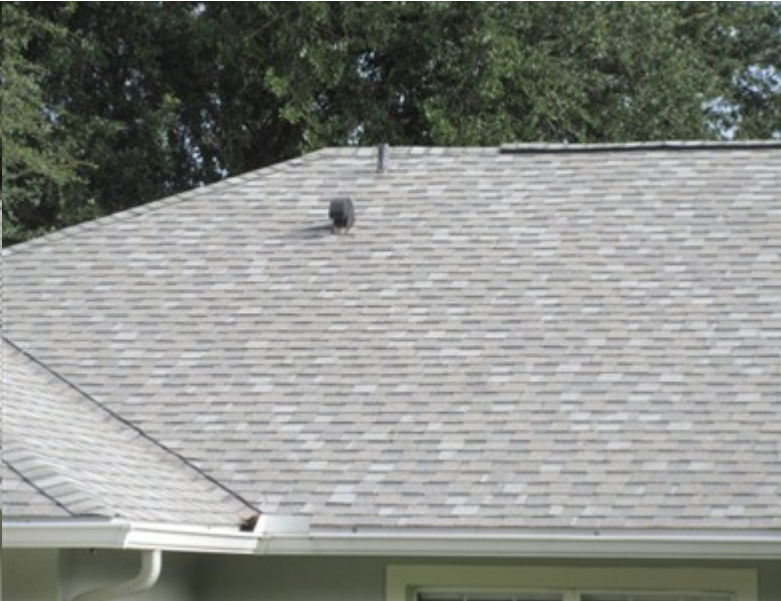
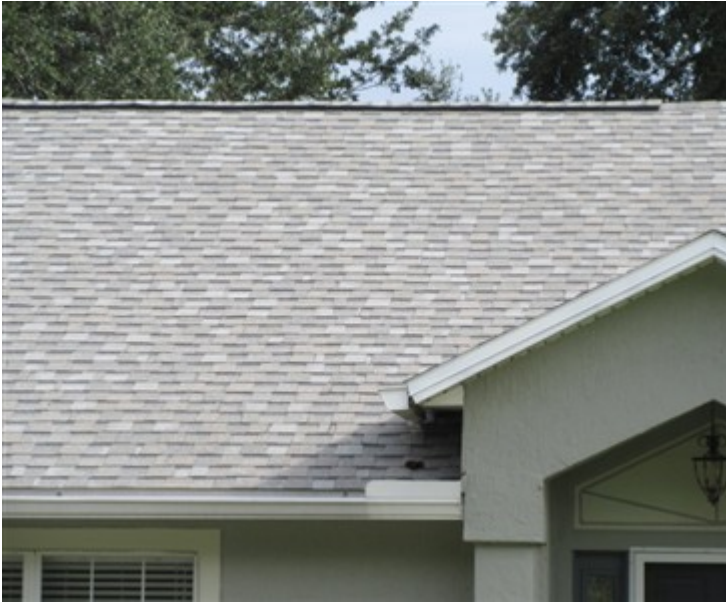
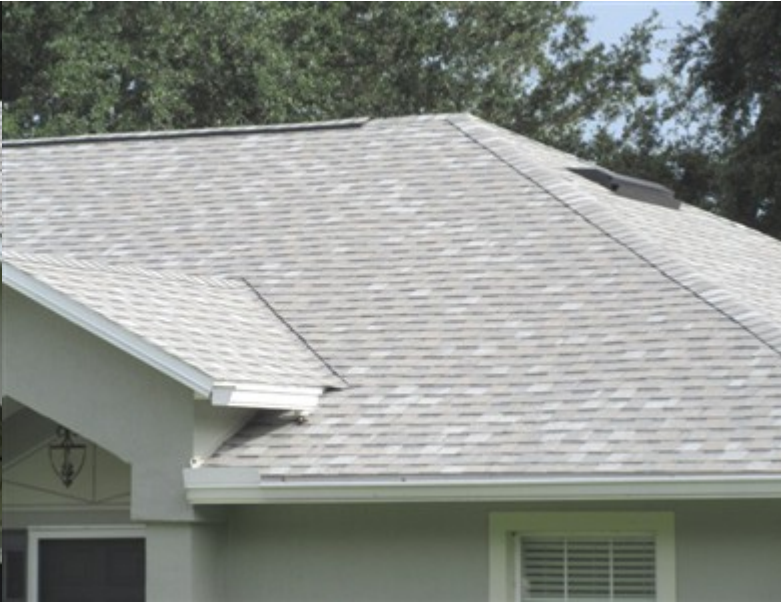
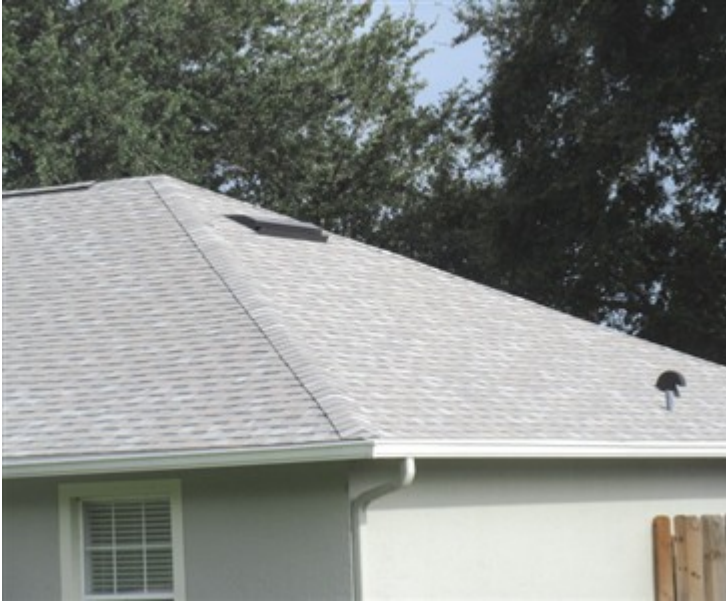
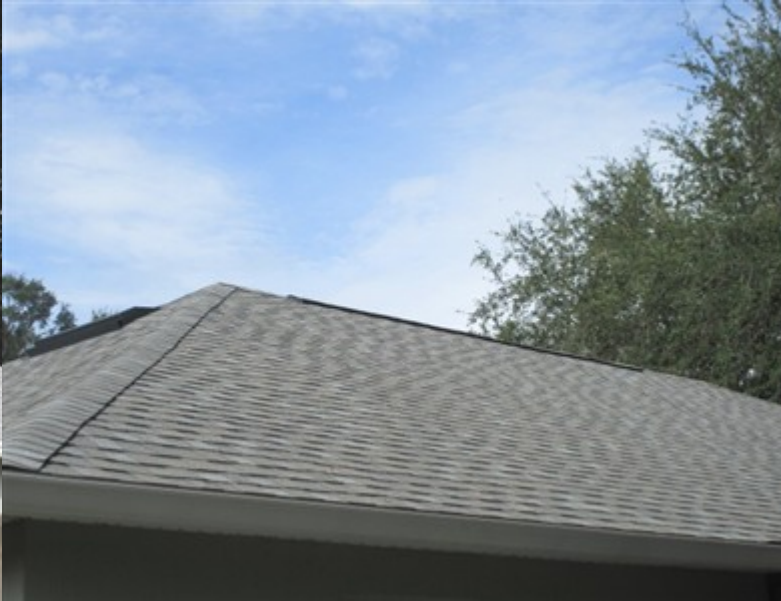
ROOF

| 4.1 Roof Covering Type: | Permit Application Date | FBC or MDC Product Approval # | Year of Original Installation or Replacement | No Information Provided for Compliance |
|---|---|---|---|---|
| <input checked="" type="checkbox"/> Asphalt/Fiberglass Shingle | 01/01/2016 | | 2016 | <input type="checkbox"/> |

☒ A. Hip Roof: Hip roof with no other roof shapes greater than 10% of the total roof system perimeter.

Total length of non-hip features: 6 feet; Total roof system perimeter: 196 feet.

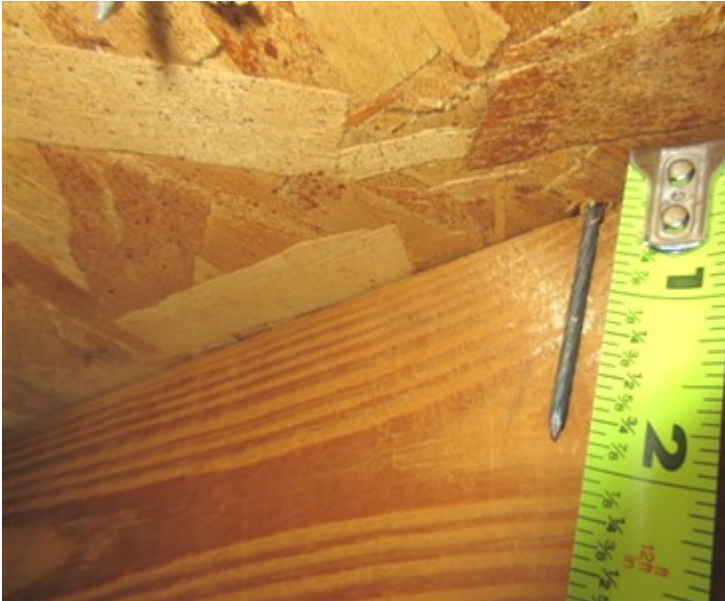
ROOF ATTACHMENT

- ☒ C. Plywood/OSB roof sheathing with a minimum thickness of 7/16" attached to the roof truss/rafter (spaced a maximum of 24" o.c.) by 8d common nails spaced a maximum of 6" in the field. **OR** Dimensional lumber/Tongue & Groove decking with a minimum of 2 nails per board (or 1 nail per board if each board is equal to or less than 6" in width). **OR** Any system of screws, nails, adhesives, other deck fastening system or truss/rafter spacing that is shown to have an equivalent or greater resistance than 8d common nails spaced a maximum of 6" in the field (max 24" truss/rafter spacing) or has a mean ultimate uplift resistance of at least 182 psf.

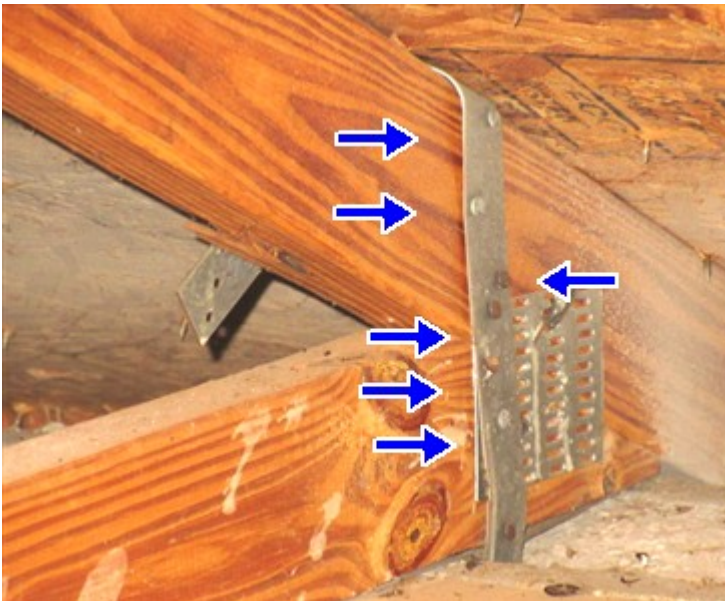
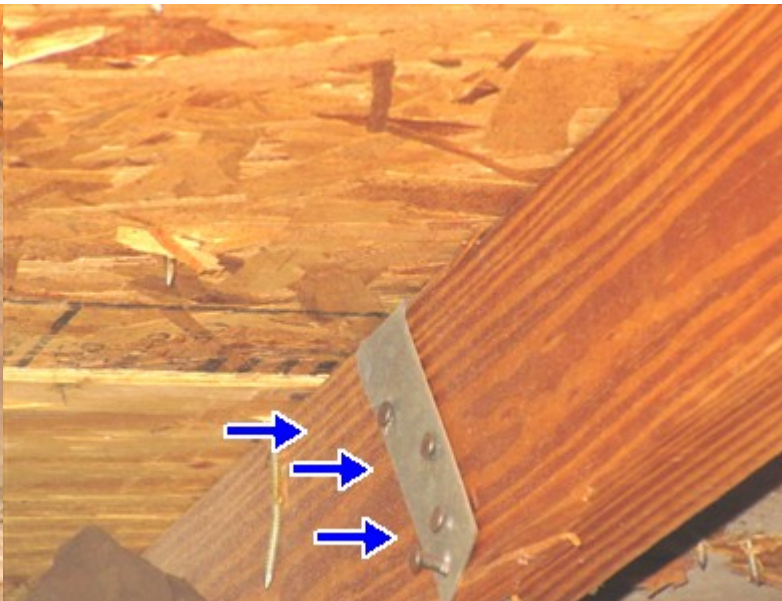
WALL TO ROOF CONNECTION

☒ C. Single Wraps:

- ☒ Metal connectors consisting of a single strap that wraps over the truss/rafter and are secured with a minimum of two (2) nails on one side and a minimum of one (1) nail on the opposing side, **OR**
- ☐ Purpose-made metal connector(s) or structural fastener(s) with a substantiated wind allowable uplift capacity of 535 lbs. or greater installed per the manufacturer's installation specifications (requires site-specific documentation).

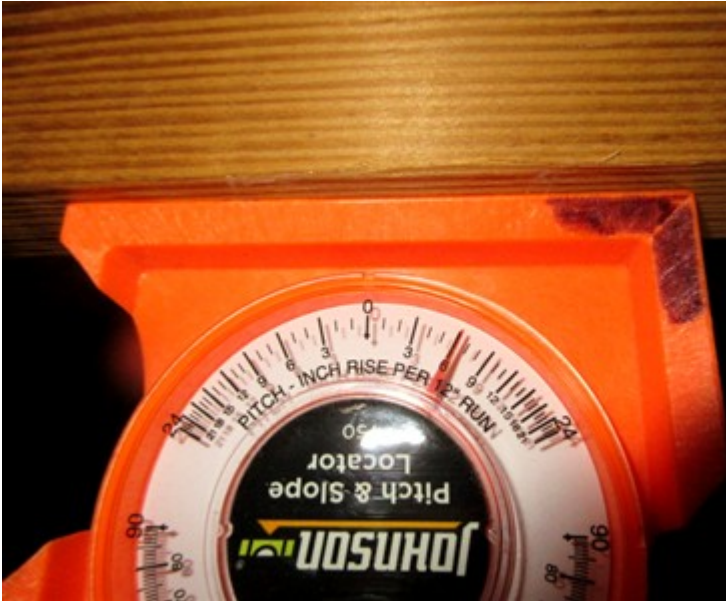
PITCH

- ☒ Greater than or equal to (≥ 6:12) ☐ Less than (< 6:12).

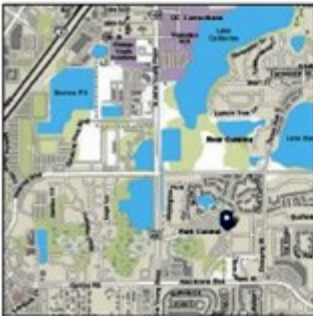
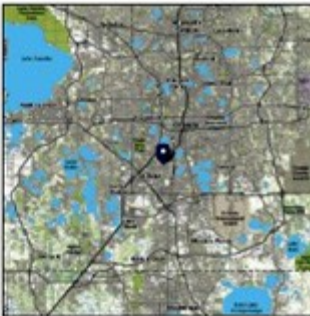
ASCE WIND ZONE

- ☐ HVHZ ☐ Region 1 (≥ 140 mph) ☒ Region 2 (130 mph – 139 mph) ☐ Region 3 (< 130 mph)

| Wind Speed | 137 Vmph |

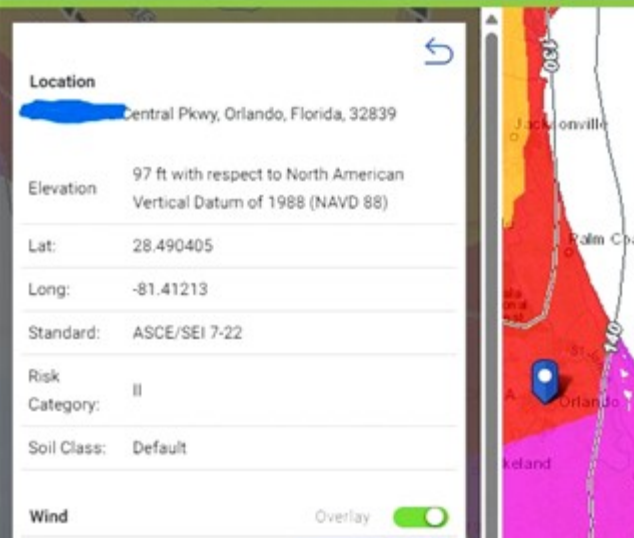
ASCE HAZARD TOOL

| 700-year MRI | 137 Vmph |

Value provided is 3-second gust wind speeds at 33 ft above ground for
